Changing a CF Card – TS910 / TS915

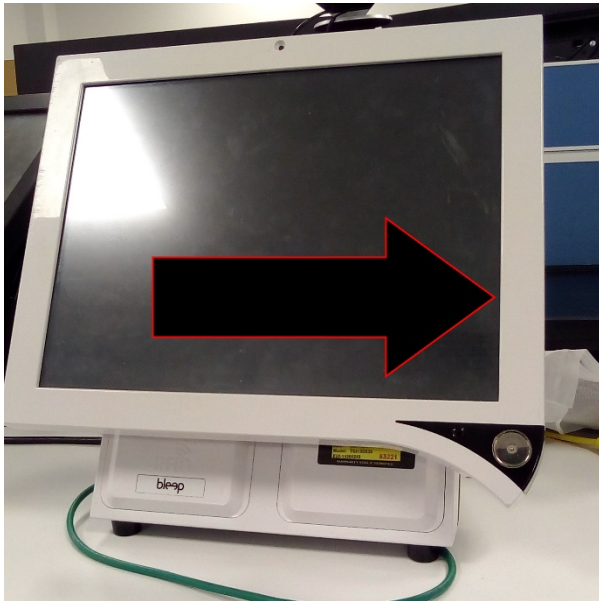
Before you start swapping the CF cards in any tills, first ensure that the power cable is disconnected. If there's any power going through the till when the card is taken out or inserted it can corrupt the card and render it unusable.

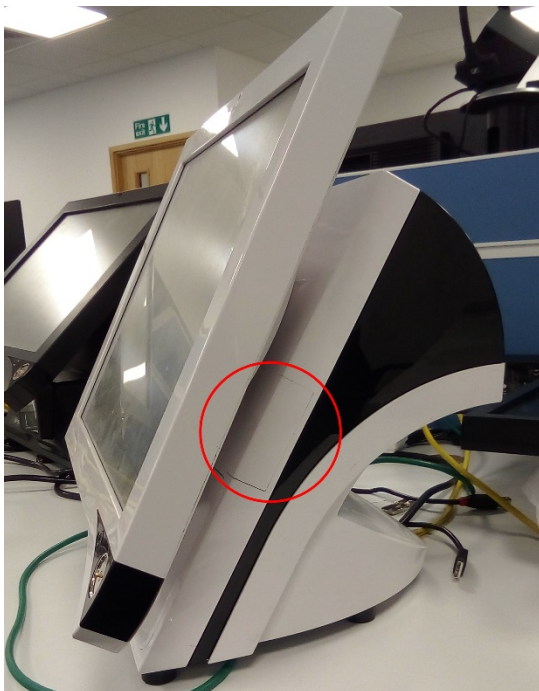
The CF card is located on the right-hand side, as you are looking at the till from the front. You can see the cover for the CF card slot on the side. This pulls out, although they can sometimes be a little stiff.

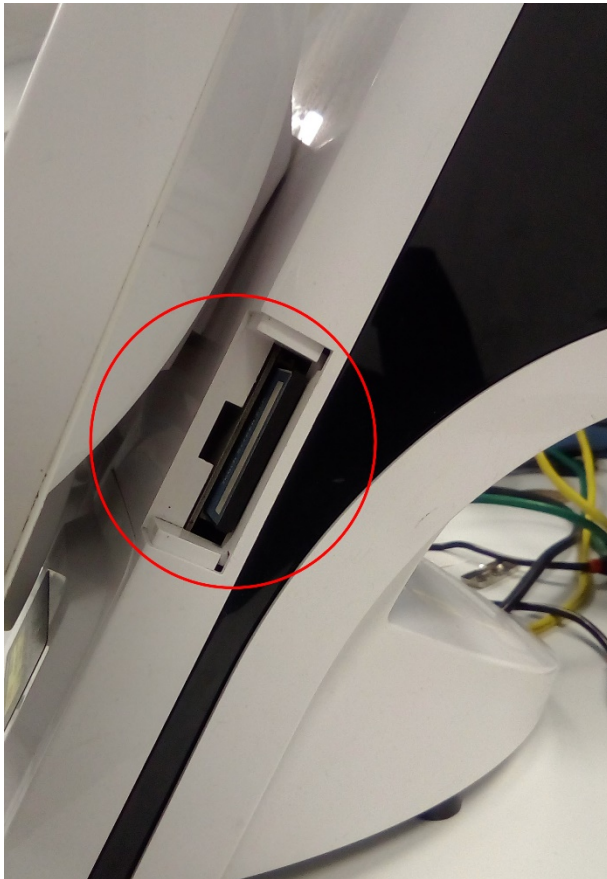
Then you can see the slot. Pay attention to the pins at the back. It's important that the FC card slots into these properly. If it's forced in without being properly aligned, then the till will not work and require repair.

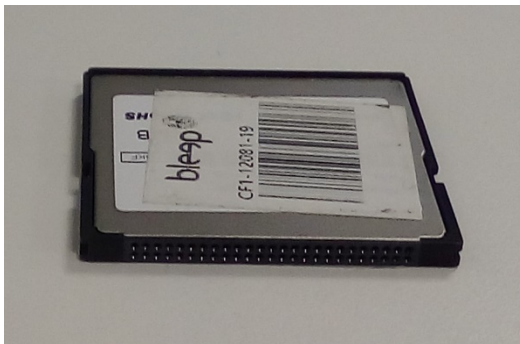
Carefully remove the CF card from the faulty unit and bring it to the loaner. Line it up in the guide rails on either side of the slot. The sticker of the card should be facing up. Once you've got that lined up push the card into place. Don't force it, just push gently until it's in as far as it goes.

Once that's in then you can reconnect the power and turn the till back on. If you get an error along the lines of "insert boot media" then the till isn't seeing the card. Often, it is just not properly seated. Double check the card is in correctly, and if you're still having issues then call the support line for advice.
